STREAM GAGE SITING MEMORANDUM
SUPPLEMENTAL ENVIRONMENTAL PROJECT

PASO ROBLES AREA GROUNDWATER SUBBASIN
SAN LUIS OBISPO COUNTY
CALIFORNIA

Prepared for
CITY OF PASO ROBLES

NOVEMBER 2020

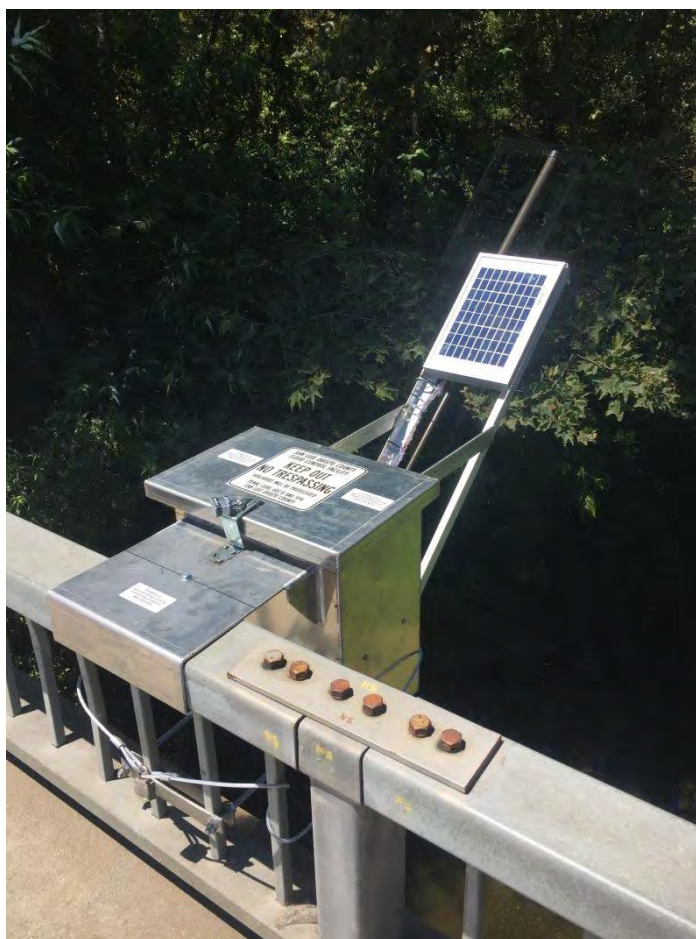
Figure 2. San Luis Obispo County radar sensor stream gage installation

Radar sensors have proven reliable and are being widely used by the County of San Luis Obispo. An example of a local radar sensor installation is shown in Figure 2.

Due to the funding requirement for installation before the end of the year, an initial key criterion that was used in the site selection process was ease of installation. For this project, non-contact radar sensors installed on bridges are preferred over bubbler or stilling well systems, as no actual work in the stream bed is needed, making the permitting and installation process significantly quicker. Radar sensors also require less maintenance than traditional water-level sensors as they are not susceptible to being obstructed by sediment or debris during high flow events. USGS testing and field experience has proven that radar water level sensors can be used at many sites to provide water level measurements that have accuracy similar or better than that of the older water level instruments³.

Bridge sites are ideal for radar sensors and do not require cableway infrastructure for velocity measurements during rating curve (stage-discharge relation) development, therefore, sites with bridges were prioritized for this project. Bridge plans often have historic topographic information that can be compared to existing or future streambed topography. Bridge sites that are located on County roads or private property (with cooperative owners) were preferred over State of California (Caltrans) owned bridges to avoid administrative delays.

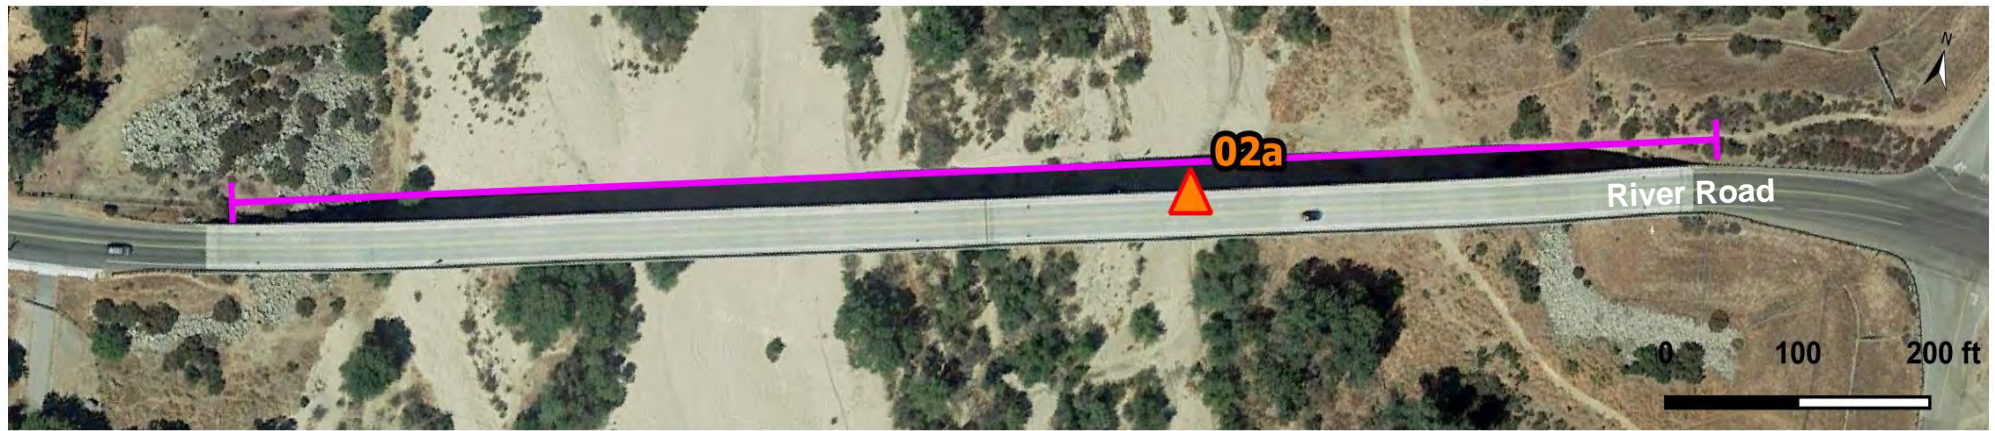
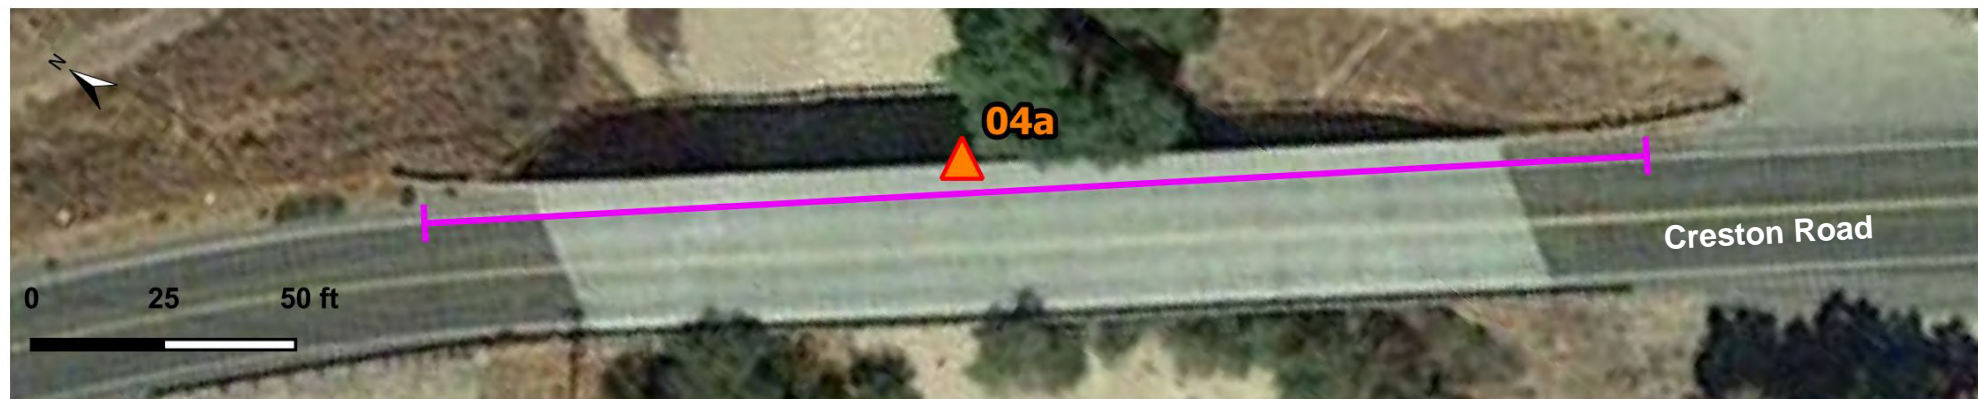
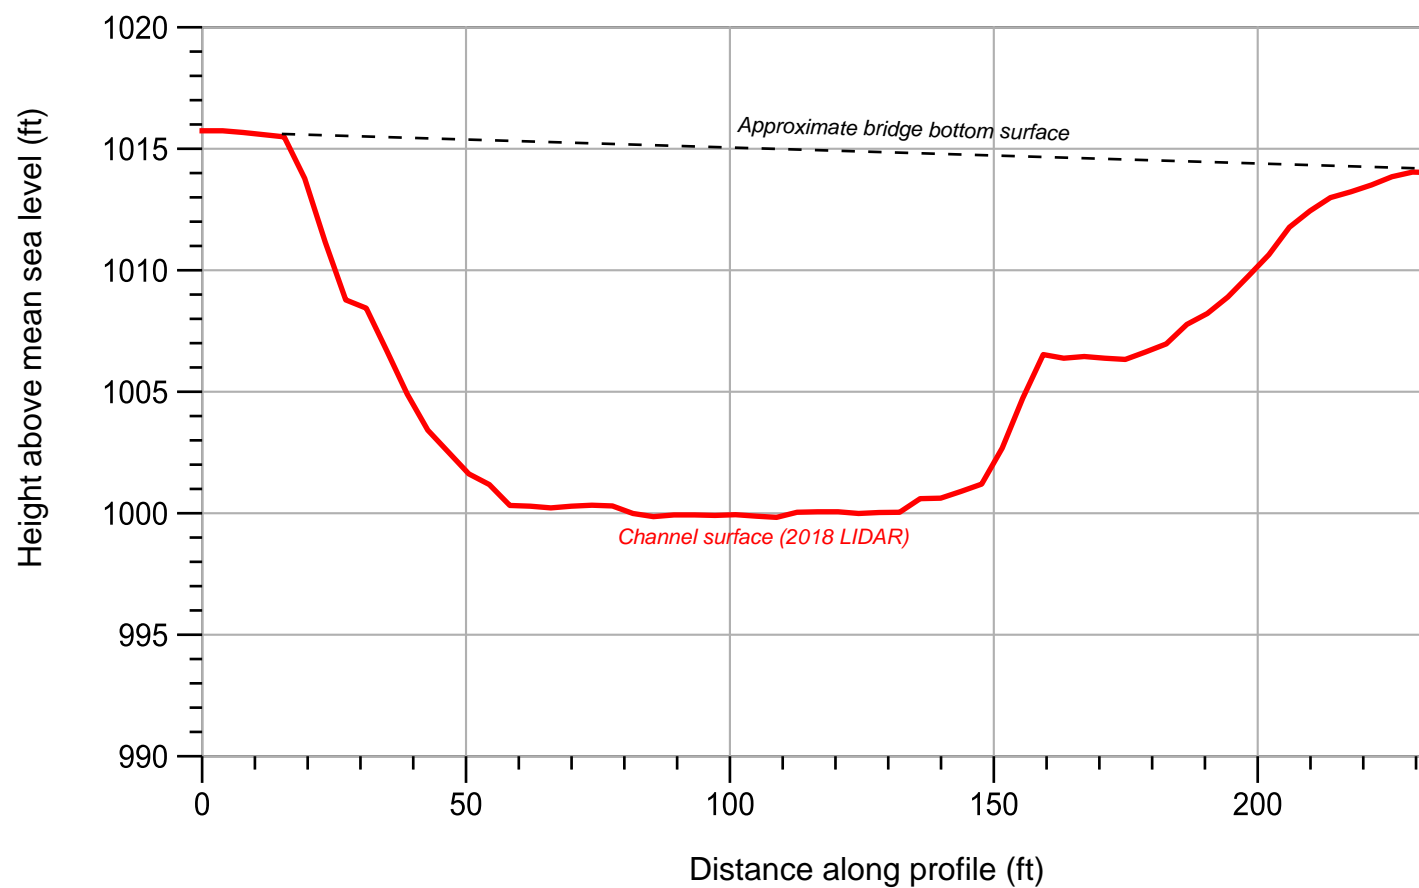
Stream Profiles at SEP Sites

Radar is a non-contact method of measuring stage at one location over time, and is best suited to channels where low flow consistently appears in a specific area of the channel, which also means the lowest point in the channel does not change from year to year. Other in-stream (contact) methods, such as bubble gages or stilling wells, are set into the channel bottom and can record stage from any location in the channel, with surface flow interpreted to occur when the stage rises above a predetermined channel or pool elevation. As previously noted, this SEP proposes radar sensor equipment installation. Some of the sites appear better suited for low flow detection than others, based on site reconnaissance. Stream bed profiles with anticipated placement of the radar gage are shown in Appendix C.

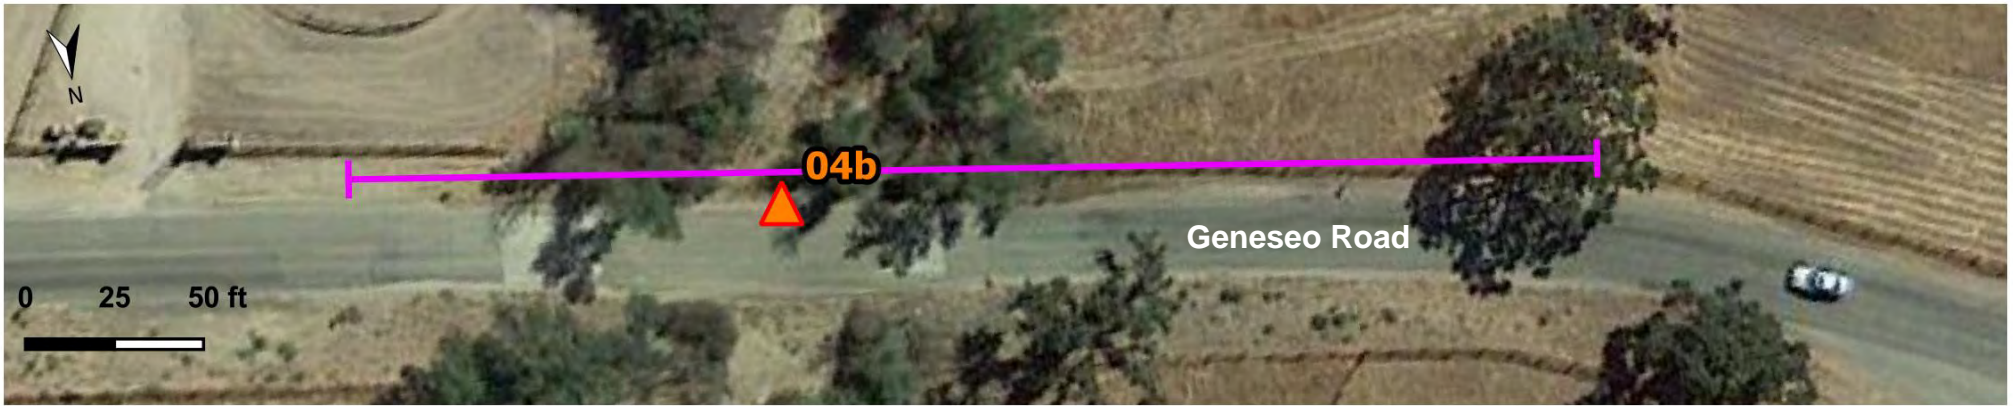
**Channel Profile
Site 4a**

Note: Aerial imagery reflects conditions prior to the construction of bridge 49C0431

As an alternative to site 4b, the older concrete bridge on Creston Road by the intersection of Geneseo Road is another potential location for a stream gage on upper Huer Huero Creek. Site 4a encompasses a watershed area of 98 square miles. The bridge deck is roughly 15 feet above a flat, 100-foot wide channel below, and is the first bridge downstream of the confluence of the West, East and Middle branches of Huer Huero Creek. Depth to water below the stream channel was approximately 85 feet in Spring 2019. The bridge is just upstream of where surface flow was identified to stop in the wet winter of 2016-17⁶. There is an adjacent County parcel to the southeast of the bridge that would be an ideal place for monitoring well installations.
